# CASE STUDIES

## USE OF CEM-OSTETIC® FOR REPAIR OF DISTAL RADIUS FRACTURE

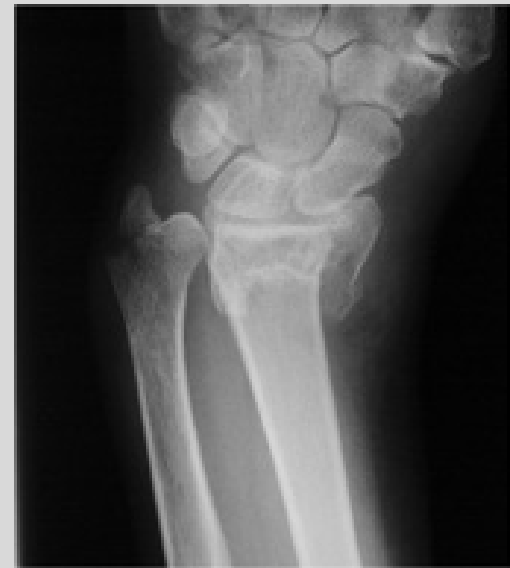
**Figure 1.** Preoperative: AP and lateral views demonstrating complex comminuted extra-articular distal radius fracture with osteoporotic bone, with marked displacement and angulation.

A 70-year-old woman presented complaining of isolated right wrist pain after sustaining a mechanical fall onto her outstretched right hand. She had no previous history of injury to the right wrist. Radiographs demonstrated an angulated comminuted extra-articular fracture of the right distal radius with osteoporotic bone and substantial collapse. A displaced fracture of the ulnar styloid was also seen (Figure 1).

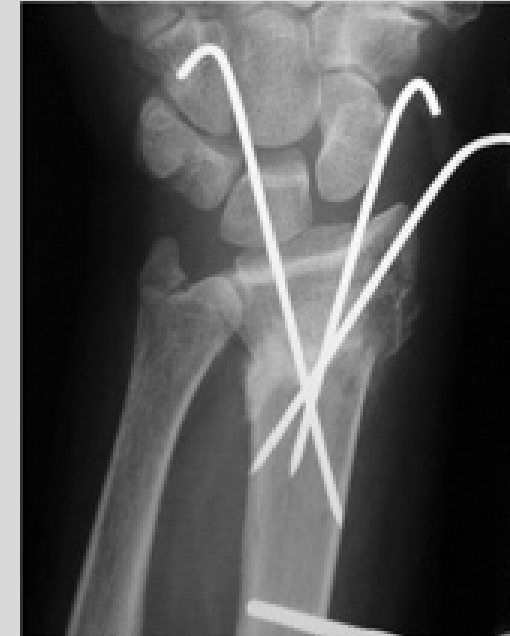
**Figure 2.** One week post-operative: X-rays demonstrating reduction of the fracture maintained with three percutaneous pins and external fixation. Cem-Ostetic® putty is visualized as radiodense material in the fracture site.

Radiographs throughout the postoperative course demonstrated rapid healing of the fracture (Figures 2 and 3). Remodeling of the putty was seen from 1 - 3 weeks postoperatively at a time correlating with formation of osteoid. Solid bridging callous formation was clearly evident at three months postoperatively with the greatest bone formation seen in the distribution of the Cem-Ostetic® putty placement (Figure 4).

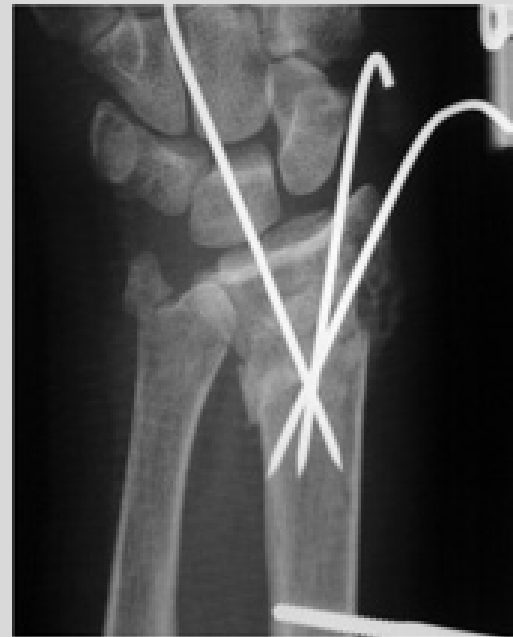
**Figure 3.** Three weeks postoperative: AP views of the fracture demonstrate remodeling of the Cem-Ostetic® putty compared to one week postoperative views with excellent maintenance of the fracture reduction.

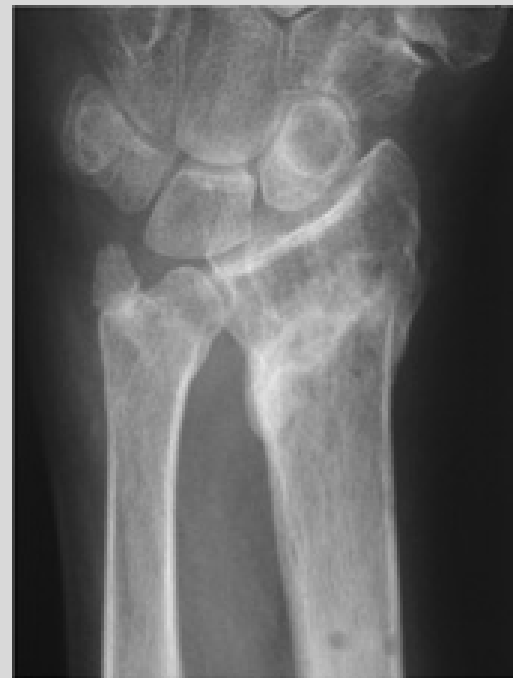
**Figure 4.** Three months postoperative: X-ray demonstrates the well healed fracture with solid bridging callous formation. The percutaneous pins and external fixator have been removed prior to this time.
